NZHA Helicopter Safety Initiative – Notice 1 – Treating the Biggest Cause of NZ Helicopter Accidents

Loss of Control – Performance Management (LOC – PM)

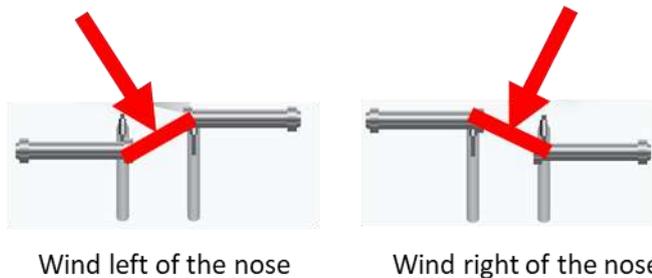
- Draw a line between the pedals on approach, a perpendicular line can indicate the side the wind is coming from.

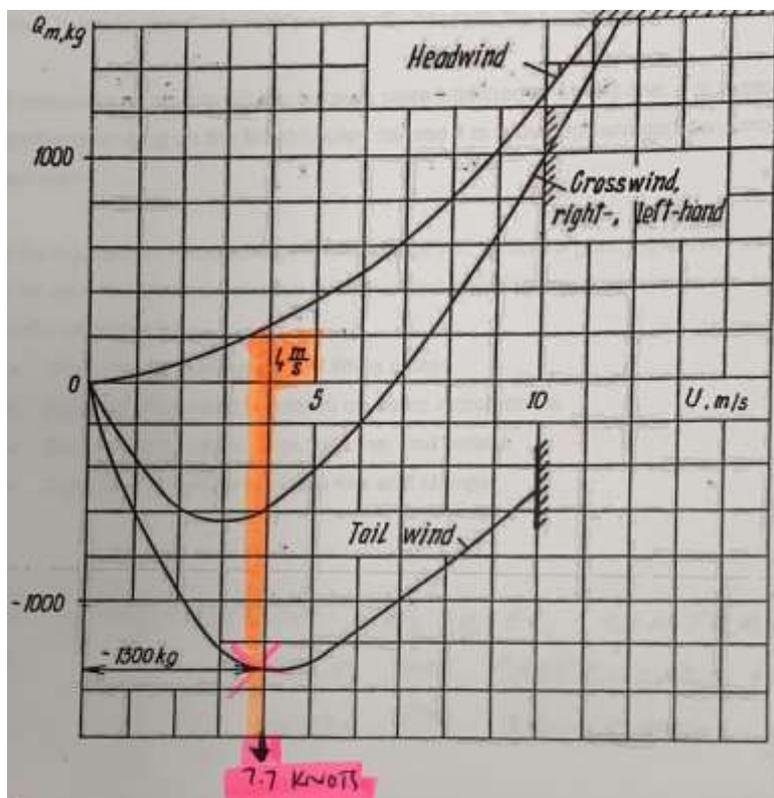
Mi-8MTV-1 Performance Graph – Weight vs Wind Velocity and Direction with use of ground effect.

This Mi-8MTV-1 graph highlights a 10% performance degradation with 7.7 knots of tail wind (MAUW 13,000kg). If you have the wind wrong the degradation in performance can be catastrophic.
